## Villages of Garrison Creek HOA Walla Walla, WA

Account 15551-- Version FINAL September 29, 2016

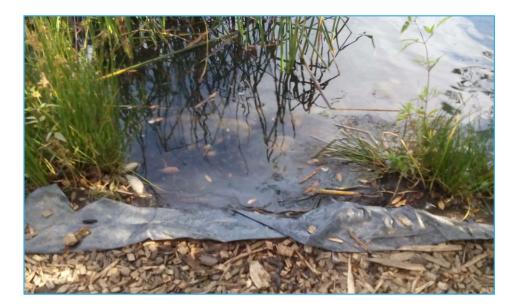
Per the Board there is no plastic liner installed in this larger community pond, however on the date of the site inspection there appeared to be a pond liner visible in numerous areas around the pond. We are recommending funding for replacement of this liner at this time due to issues with maintaining the water level of this pond and what appeared to be tears in the liner where visible.

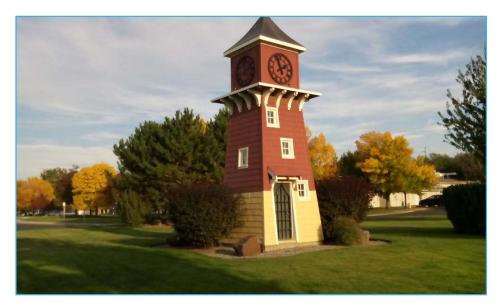
This component is for a repair contingency for the clock tower which has roofing, paint, siding, a door and clock components which will require ongoing maintenance and upkeep. We suggest budgeting at the amount and timeframe indicated to make ongoing repairs and maintenance of this component. If properly cared for we currently have no estimation for full replacement of this component. As a history of expenses occur over time we suggest incorporating these costs into future reserve studies.

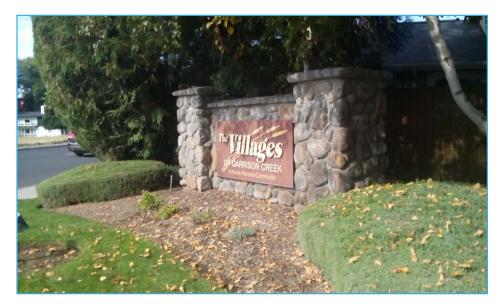
This component is for the refurbishment of the cement/mortar and replacement of the plastic/fiberglass sign on the entry monument. Most of the monument is concrete (faux rock) and is a long life component which has no predictable remaining useful life but which will require cement/mortar repairs . Note that these long life entry monument are most often replaced after vehicle damage (accidents) rather than deterioration. We recommend cleaning the monument annually to retain the aesthetic appeal of the monument.

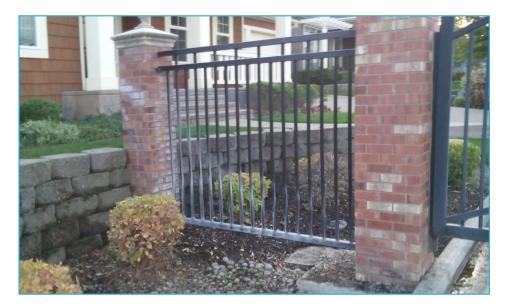
The metal and brick pillar fence at both entrances to this phase appears to be deteriorating at a rate in line with its age. The metal over time will deteriorate due to constant exposure so we recommend planning for replacement at the timeframe indicated. If properly installed the brick pillars are a long life component but which will likely require repointing of some of the brickwork in areas over time. We recommend planning for repointing/repairing a portion of the brickwork on these pillars at the amount indicated below. Over time should it appear thee pillars are deteriorating more rapidly than expected we suggest updating future reserve studies according to actual cost and on site inspection estimates.

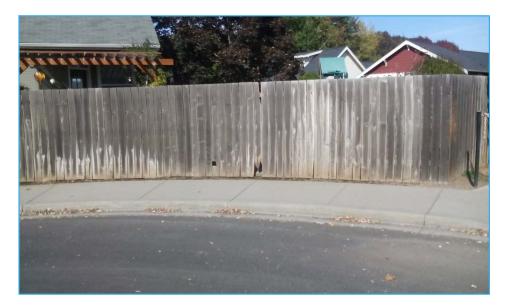
Currently there is no stain/paint/seal on the wood fence. Regular cycles of stain/paint will help to maintain appearance and maximize life (longer than current useful life estimate). Cost estimate includes 1 primer coat and 1 top coat.

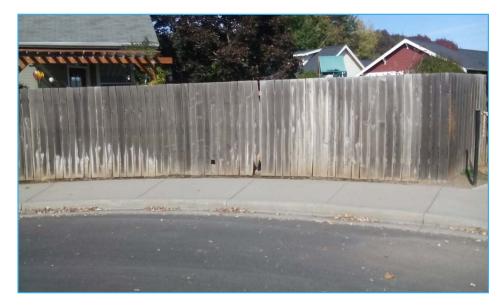
Wood fencing appears to be deteriorating at a rate typical of its age and is nearing the end of its useful life. There are numerous areas of failure and warping wood but no large scale instability observed at this time. As routine maintenance, inspect regularly for any damage, repair as needed. Avoid contact with ground and surrounding vegetation. Regular cycles of stain/paint will help to maintain appearance and maximize life (longer than current useful life estimate). Plan to replace at roughly the time frame indicated.

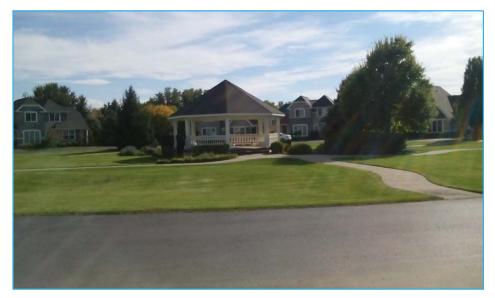
This component is for the painting and sealing (caulking where needed) of the gazebo which we recommend regular paint cycles of every 6 years to maintain the aesthetic appeal of the community as well as extend the useful life of this component.

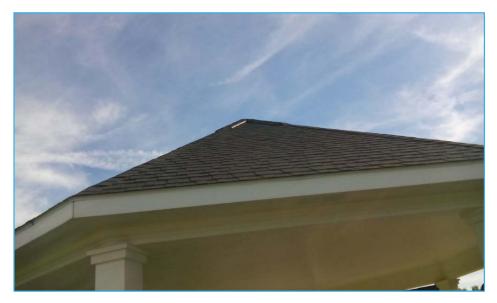
Appears to be deteriorating at a rate typical of its age based our limited scope visual inspection. Reportedly installed in 2007. As routine maintenance, we recommend professional inspections at least twice annually and after windstorms. Promptly replace any damaged/missing shingles or any other repair needed to ensure waterproof integrity of roof. Keep gutters and downspouts clear and free of debris. Plan for replacement at roughly the time frame indicated. Cost estimates include removal of old roofing materials and replacement of flashing.

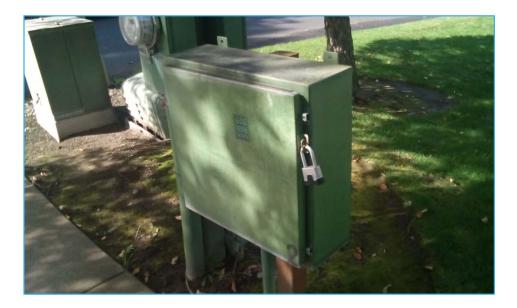
Reported to be functioning properly with no significant repair/replacement history. It is not known when each controller was last replaced so this component has been set for 20% of them to be replaced every 3 years; there will be a full cycle of replacement every 15 years which is the typical useful life of irrigation controllers.

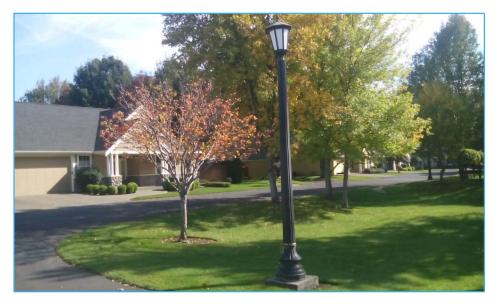
Pole light fixtures appear to be deteriorating at a rate typical of a component of this age. This component is for replacement of the ballast and pole mounted fixtures which will typically deteriorate with time.

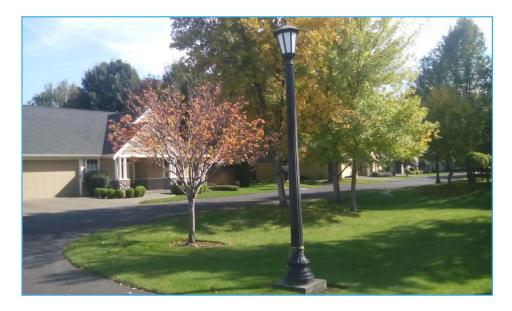
Pole lights appear to be deteriorating at a rate typical of a component of this age. The exterior paint on the lights have significant fading and wear. This component is for full replacement of the metal poles and fixtures which will typically deteriorate with time due to constant exposure to the elements.

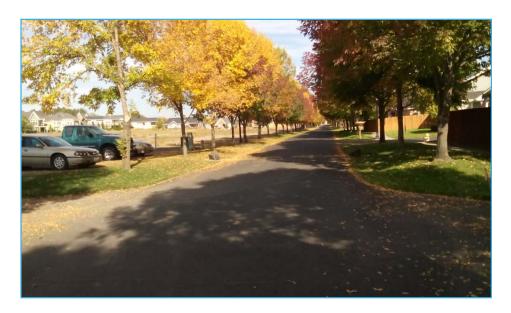
Appears to be deteriorating at a rate typical of its age. As routine maintenance, keep surface clean, ensure that drains are clean and free flowing, repair cracks and clean oils stains promptly. Best to plan for eventual intervals of resurface (overlay).

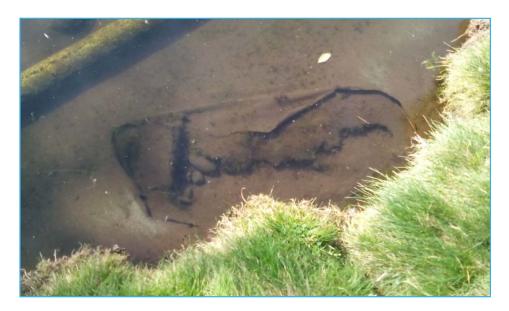
Pond liners at the small and large pond are in poor condition with numerous areas of rips and tears visible. We recommend a pond assessment be conducted on each pond to determine the most appropriate and cost efficient method to replace these liners which complying with all required government regulations. The cost estimate in this study is based on removal of the old liner and replacement with a new one in each pond.

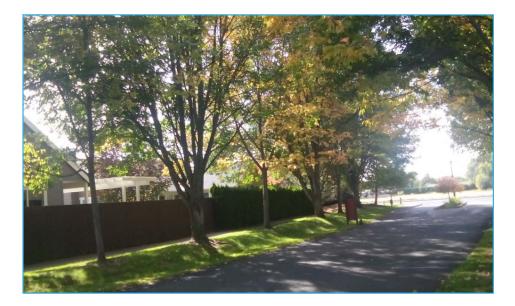
This component is for tree care of the large trees in the community. These large trees require regular trimming/thinning/root control to prevent damage to nearby walkways, roads and underground piping. The provided cost estimate is based on our estimation for the total expected cost for all the trees in the community and is based on the historical records provided by the Board.

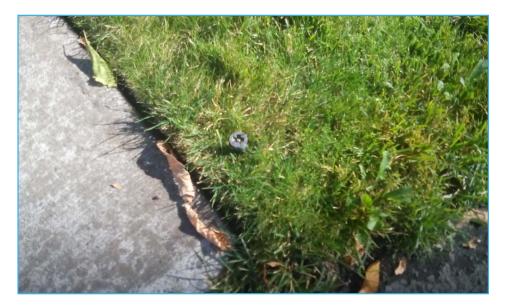
Underground sprinkler piping, over time, will deteriorate as well as become damaged from root intrusion by trees and shrubs. Due to the age of the community and likelihood of underground sprinkler issues in the near future we recommend for replacement of these pipes at the timeframe indicated which is typical of this type of component. There have reportedly been some areas of repair already required due to root intrusion issues. This cost estimate includes replacement of the underground piping and the landscaping which will be torn up in the process. Since this type of component does not typically fail all at once we recommend funding for a repair contingency of 5% per cycle so that over time the whole system will be replaced as each begins to fail.

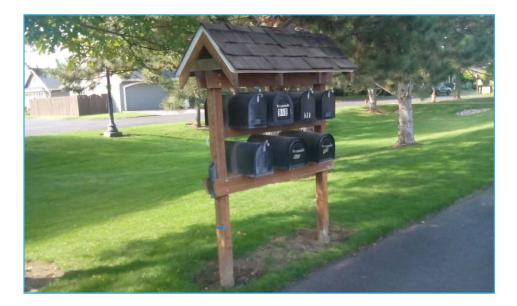
Appears to be deteriorating at a rate typical of their age based on our visual inspection of this component. As routine maintenance, inspect regularly, paint/stain and complete minor repairs as needed from operating budget. Best to plan for total replacement at roughly the time frame indicated due to constant usage, exposure to the elements and wear over time.

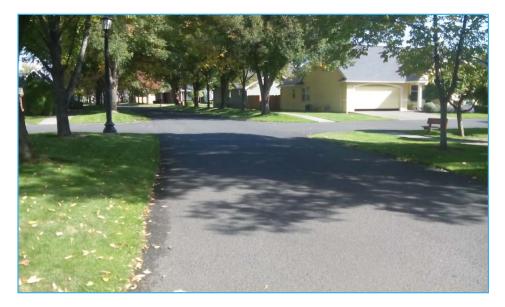
Appears to be deteriorating at a rate typical of its age. As routine maintenance, keep surface clean, ensure that drains are clean and free flowing, repair cracks and clean oils stains promptly. Best to plan for eventual intervals of resurface (overlay).

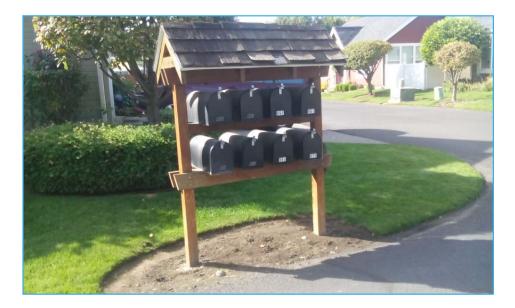
Appears to be deteriorating at a rate typical of their age based on our visual inspection of this component. As routine maintenance, inspect regularly, paint/stain and complete minor repairs as needed from operating budget. Best to plan for total replacement at roughly the time frame indicated due to constant usage, exposure to the elements and wear over time.

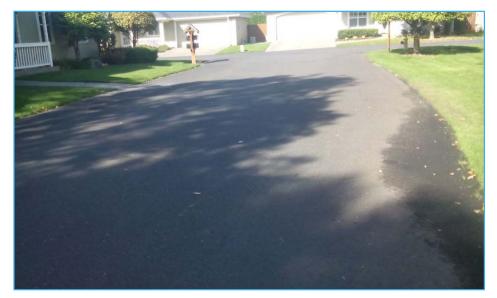
Appears to be deteriorating at a rate typical of its age. As routine maintenance, keep surface clean, ensure that drains are clean and free flowing, repair cracks and clean oils stains promptly. Best to plan for eventual intervals of resurface (overlay).

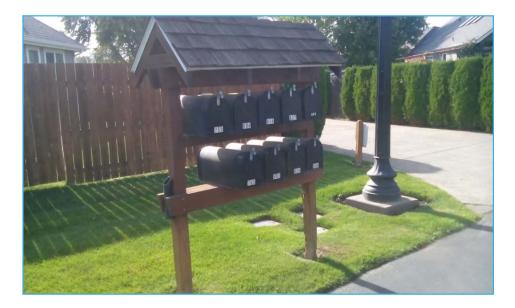
Appears to be deteriorating at a rate typical of their age based on our visual inspection of this component. As routine maintenance, inspect regularly, paint/stain and complete minor repairs as needed from operating budget. Best to plan for total replacement at roughly the time frame indicated due to constant usage, exposure to the elements and wear over time.

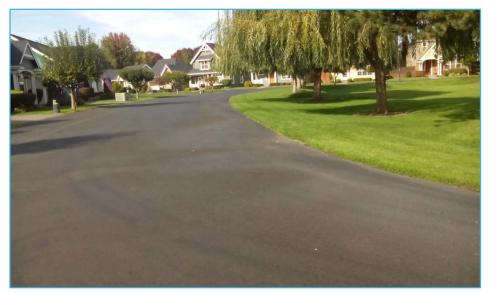
Appears to be deteriorating at a rate typical of its age. As routine maintenance, keep surface clean, ensure that drains are clean and free flowing, repair cracks and clean oils stains promptly. Best to plan for eventual intervals of resurface (overlay).

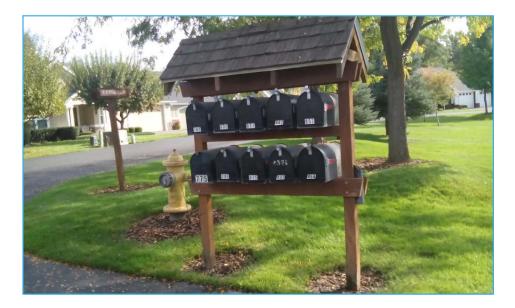
Appears to be deteriorating at a rate typical of their age based on our visual inspection of this component. As routine maintenance, inspect regularly, paint/stain and complete minor repairs as needed from operating budget. Best to plan for total replacement at roughly the time frame indicated due to constant usage, exposure to the elements and wear over time.

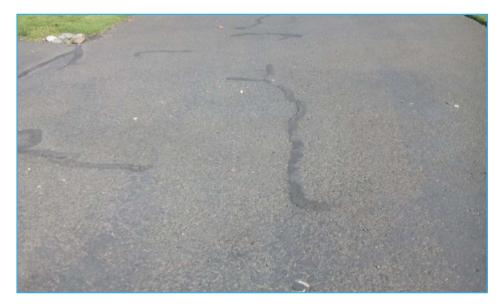
Reportedly areas which were not installed to appropriately. We have reduced the useful life of the asphalt roads in this phase as it is not likely this will last a full 30 years. As routine maintenance, keep surface clean, ensure that drains are clean and free flowing, repair cracks and clean oils stains promptly. Best to plan for eventual intervals of resurface (overlay).

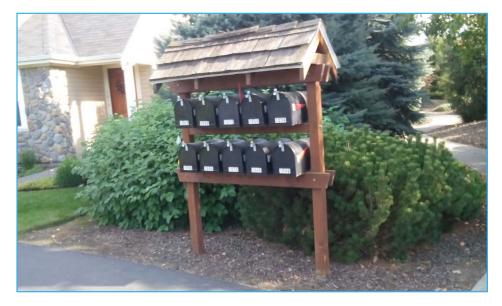
Appears to be deteriorating at a rate typical of their age based on our visual inspection of this component. As routine maintenance, inspect regularly, paint/stain and complete minor repairs as needed from operating budget. Best to plan for total replacement at roughly the time frame indicated due to constant usage, exposure to the elements and wear over time.

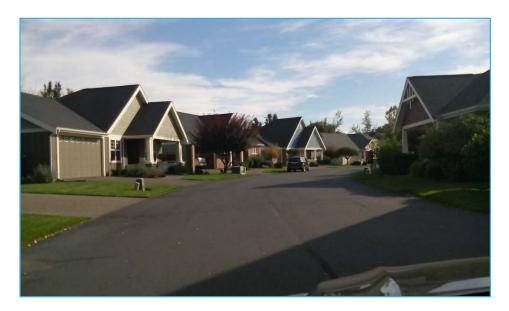
Appears to be deteriorating at a rate typical of its age. As routine maintenance, keep surface clean, ensure that drains are clean and free flowing, repair cracks and clean oils stains promptly. Best to plan for eventual intervals of resurface (overlay).

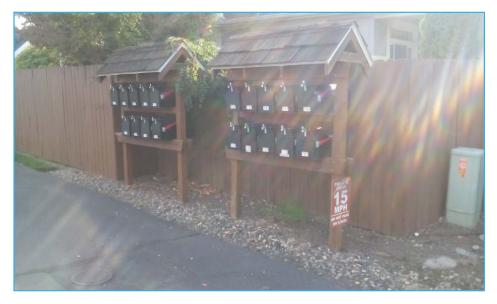
Appears to be deteriorating at a rate typical of their age based on our visual inspection of this component. As routine maintenance, inspect regularly, paint/stain and complete minor repairs as needed from operating budget. Best to plan for total replacement at roughly the time frame indicated due to constant usage, exposure to the elements and wear over time.

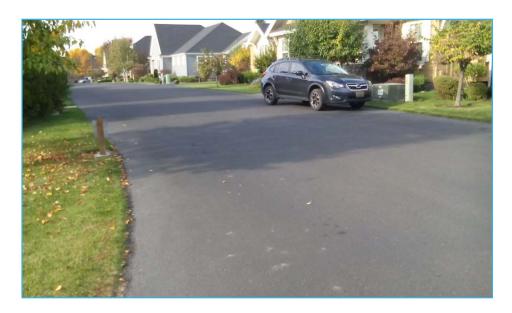
Appears to be deteriorating at a rate typical of its age. As routine maintenance, keep surface clean, ensure that drains are clean and free flowing, repair cracks and clean oils stains promptly. Best to plan for eventual intervals of resurface (overlay).

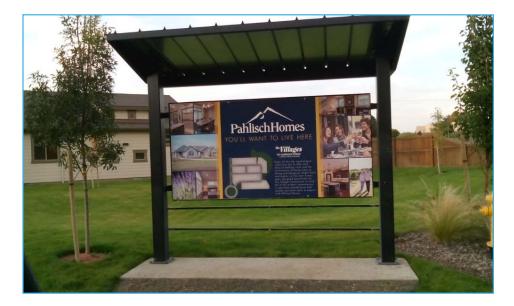
The metal bus top cover appear to be in good overall condition. If properly maintained with regular intervals of cleaning and painting (paid for from the operating budget) this component is a long life item which will not have a replacement cycle within the timeframe of this reserve study. If at a future date this structure appears to be deteriorating more rapidly then expected we recommend incorporating into future reserve studies for replacement.

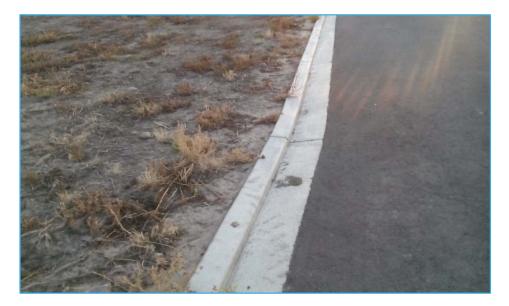
Good condition with no areas of cracking or damage noted. No instability observed at this time. Inspect regularly, pressure wash for appearance and repair as needed from operating budget. No expectation for large scale replacement at this time, if patterns of deterioration emerge, incorporate funding into future reserve study updates as conditions merit.
