Villages of Garrison Creek HOA Walla Walla, WA

Account 15551b-- Version Draft1 October 20, 2017

Villages of Garrison Creek HOA Summary Page

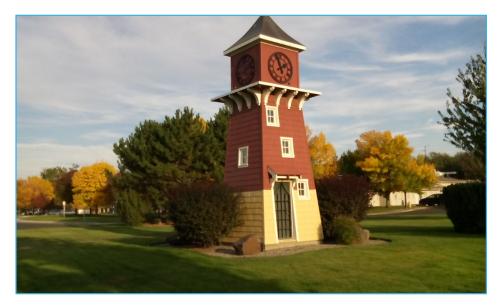
This component is for a repair contingency for the clock tower which has roofing, paint, siding, a door and clock components which will require ongoing maintenance and upkeep. We suggest budgeting at the amount and timeframe indicated to make ongoing repairs and maintenance of this component. If properly cared for we currently have no estimation for full replacement of this component. As a history of expenses occur over time we suggest incorporating these costs into future reserve studies.

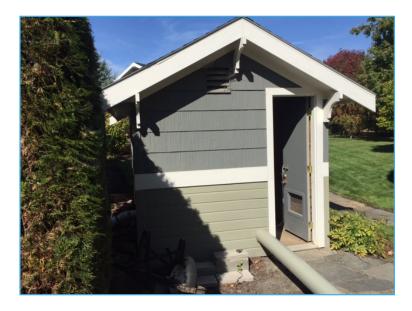
This component is for a repair contingency for the shed which has roofing, paint, siding and a door which will require ongoing maintenance and upkeep. We suggest budgeting at the amount and timeframe indicated to make ongoing repairs and maintenance of this component. If properly cared for we currently have no estimation for full replacement of this component. As a history of expenses occur over time we suggest incorporating these costs into future reserve studies.

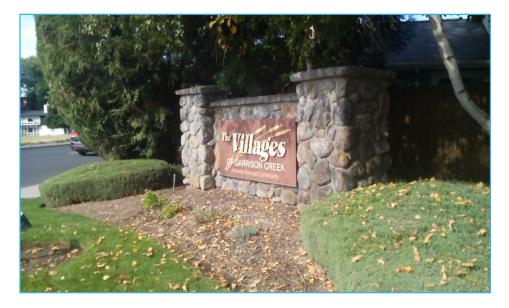
This component is for the refurbishment of the cement/mortar and replacement of the plastic/fiberglass sign on the entry monument. Most of the monument is concrete (faux rock) and is a long life component which has no predictable remaining useful life but which will require cement/mortar repairs . Note that these long life entry monument are most often replaced after vehicle damage (accidents) rather than deterioration. We recommend cleaning the monument annually to retain the aesthetic appeal of the monument.

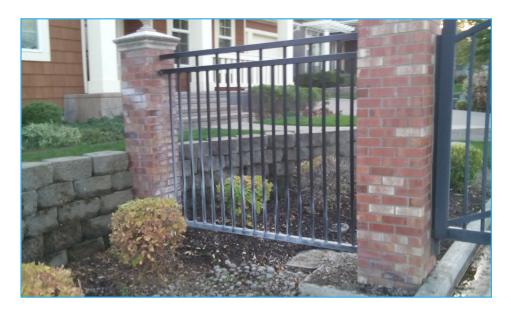
The metal and brick pillar fence at both entrances to this phase appears to be deteriorating at a rate in line with its age. The metal over time will deteriorate due to constant exposure so we recommend planning for replacement at the timeframe indicated. If properly installed the brick pillars are a long life component but which will likely require repointing of some of the brickwork in areas over time. We recommend planning for repointing/repairing a portion of the brickwork on these pillars at the amount indicated below. Over time should it appear thee pillars are deteriorating more rapidly than expected we suggest updating future reserve studies according to actual cost and on site inspection estimates.

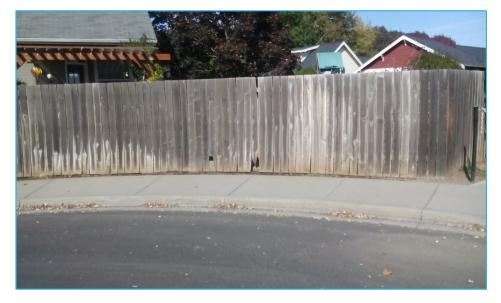
Currently there is no stain/paint/seal on the wood fence. Regular cycles of stain/paint will help to maintain appearance and maximize life (longer than current useful life estimate). Cost estimate includes 1 primer coat and 1 top coat.

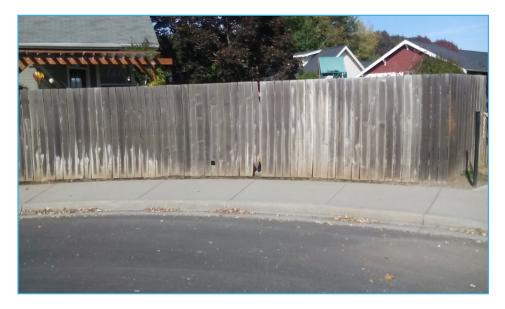
Wood fencing appears to be deteriorating at a rate typical of its age and is nearing the end of its useful life. There are numerous areas of failure and warping wood but no large scale instability observed at this time. As routine maintenance, inspect regularly for any damage, repair as needed. Avoid contact with ground and surrounding vegetation. Regular cycles of stain/paint will help to maintain appearance and maximize life (longer than current useful life estimate). Plan to replace at roughly the time frame indicated.

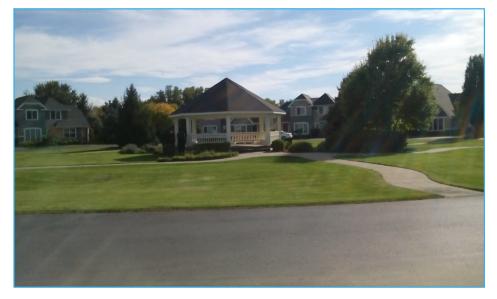
This component is for the painting and sealing (caulking where needed) of the gazebo which we recommend regular paint cycles of every 6 years to maintain the aesthetic appeal of the community as well as extend the useful life of this component.

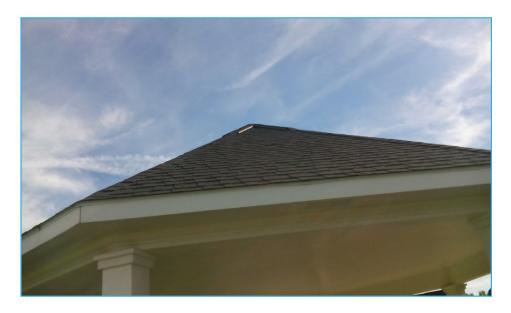
Appears to be deteriorating at a rate typical of its age based our limited scope visual inspection. Reportedly installed in 2007. As routine maintenance, we recommend professional inspections at least twice annually and after windstorms. Promptly replace any damaged/missing shingles or any other repair needed to ensure waterproof integrity of roof. Keep gutters and downspouts clear and free of debris. Plan for replacement at roughly the time frame indicated. Cost estimates include removal of old roofing materials and replacement of flashing.

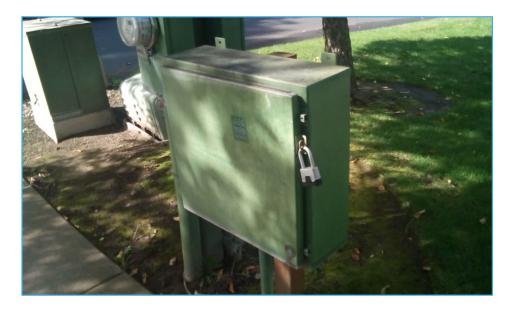
Reported to be functioning properly with no significant repair/replacement history. It is not known when each controller was last replaced so this component has been set for 20% of them to be replaced every 3 years; there will be a full cycle of replacement every 15 years which is the typical useful life of irrigation controllers.

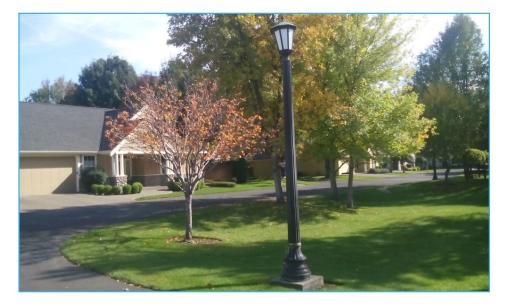
Pole light fixtures appear to be deteriorating at a rate typical of a component of this age. This component is for replacement of the ballast and pole mounted fixtures which will typically deteriorate with time.

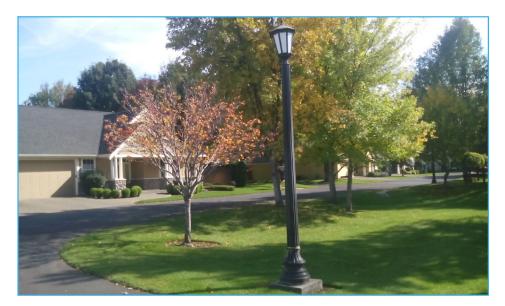
Pole lights appear to be deteriorating at a rate typical of a component of this age. The exterior paint on the lights have significant fading and wear. This component is for full replacement of the metal poles and fixtures which will typically deteriorate with time due to constant exposure to the elements.

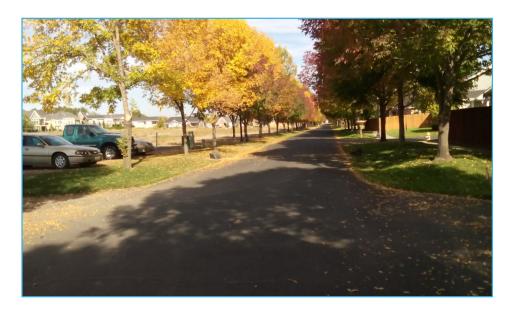
Appears to be deteriorating at a rate typical of its age. As routine maintenance, keep surface clean, ensure that drains are clean and free flowing, repair cracks and clean oils stains promptly. Best to plan for eventual intervals of resurface (overlay).

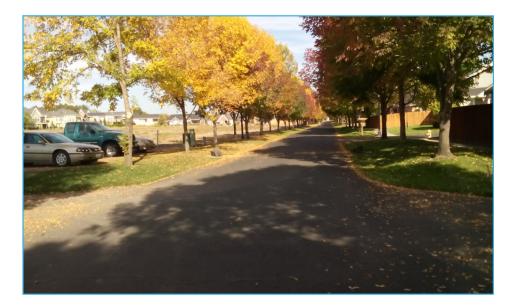
The primary reason to sealcoat is to protect the pavement from the deteriorating effects of sun and water, which causes the asphalt to harden, or oxidize. The pavement turns brittle. The sealcoat provides a waterproof membrane which slows the oxidation process and helps the pavement shed water, preventing the water to infiltrate the base material.

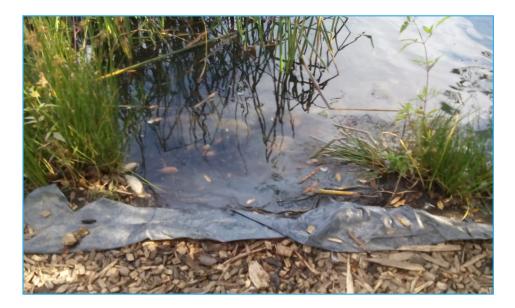
Per the Board there is no plastic liner installed in this larger community pond, however on the date of the site inspection there appeared to be a pond liner visible in numerous areas around the pond. We are recommending funding for replacement of this liner at this time due to issues with maintaining the water level of this pond and what appeared to be tears in the liner where visible.

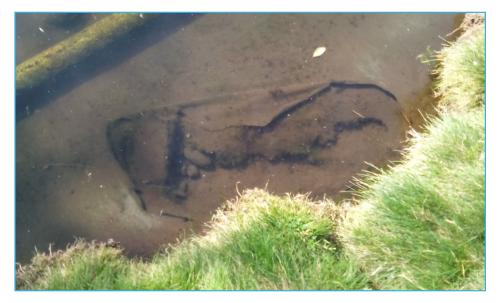
Pond liners at the small and large pond are in poor condition with numerous areas of rips and tears visible. We recommend a pond assessment be conducted on each pond to determine the most appropriate and cost efficient method to replace these liners which complying with all required government regulations. The cost estimate in this study is based on removal of the old liner and replacement with a new one in each pond.

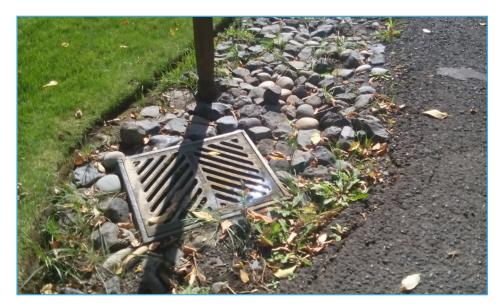
We suggest consulting with a qualified and licensed vendor to set up an annual maintenance paid for from the Operating Account. Currently the Board has stated there has been no maintenance (debris/sediment removal) from the storm water systems in the community. We have given an estimate for this first time service but actual costs may be higher if there is significant amounts of debris/sediment which requires removal.

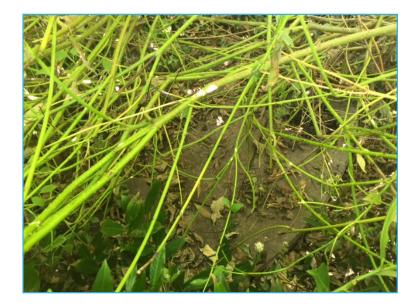
Sump pumps reportedly in working order. Replacement year and cost obtained form client records. We recommend budgeting for replacement of these sump pumps at the timeframe indicated.

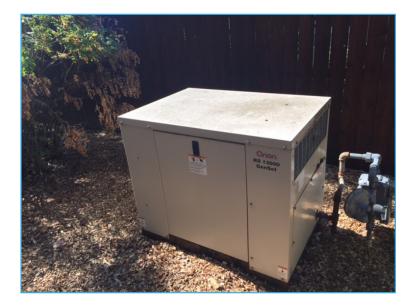
Gas generator reportedly in working condition and was installed in 2007. We recommend planning for replacement at the timeframe indicated.

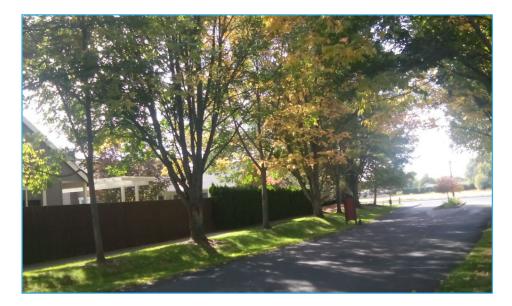
This component is for tree care of the large trees in the community. These large trees require regular trimming/thinning/root control to prevent damage to nearby walkways, roads and underground piping. The provided cost estimate is based on our estimation for the total expected cost for all the trees in the community and is based on the historical records provided by the Board.

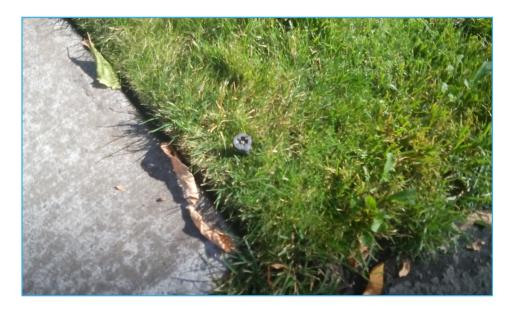
Underground sprinkler piping, over time, will deteriorate as well as become damaged from root intrusion by trees and shrubs. Due to the age of the community and likelihood of underground sprinkler issues in the near future we recommend for replacement of these pipes at the timeframe indicated which is typical of this type of component. There have reportedly been some areas of repair already required due to root intrusion issues. This cost estimate includes replacement of the underground piping and the landscaping which will be torn up in the process. Since this type of component does not typically fail all at once we recommend funding for a repair contingency of 5% per cycle so that over time the whole system will be replaced as each begins to fail.

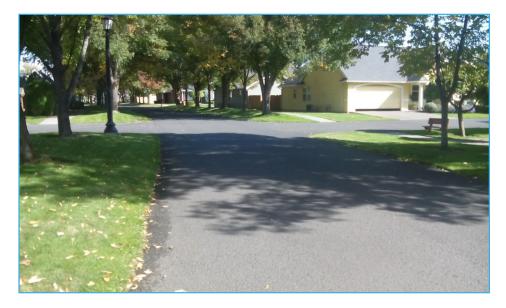
Appears to be deteriorating at a rate typical of its age. As routine maintenance, keep surface clean, ensure that drains are clean and free flowing, repair cracks and clean oils stains promptly. Best to plan for eventual intervals of resurface (overlay).

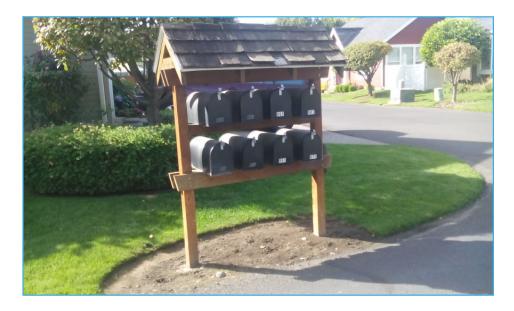
Appears to be deteriorating at a rate typical of their age based on our visual inspection of this component. As routine maintenance, inspect regularly, paint/stain and complete minor repairs as needed from operating budget. Best to plan for total replacement at roughly the time frame indicated due to constant usage, exposure to the elements and wear over time.

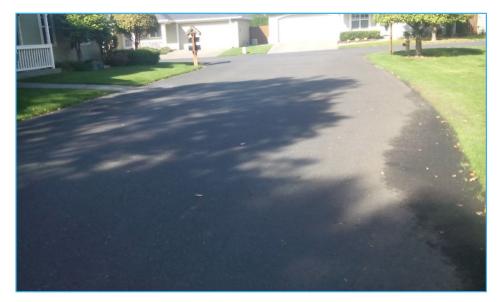
Appears to be deteriorating at a rate typical of its age. As routine maintenance, keep surface clean, ensure that drains are clean and free flowing, repair cracks and clean oils stains promptly. Best to plan for eventual intervals of resurface (overlay).

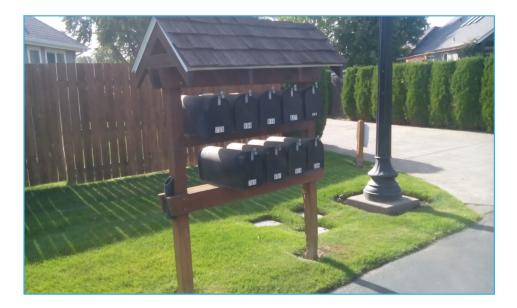
Appears to be deteriorating at a rate typical of their age based on our visual inspection of this component. As routine maintenance, inspect regularly, paint/stain and complete minor repairs as needed from operating budget. Best to plan for total replacement at roughly the time frame indicated due to constant usage, exposure to the elements and wear over time.

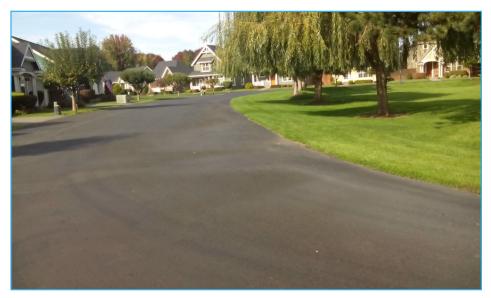
Appears to be deteriorating at a rate typical of its age. As routine maintenance, keep surface clean, ensure that drains are clean and free flowing, repair cracks and clean oils stains promptly. Best to plan for eventual intervals of resurface (overlay).

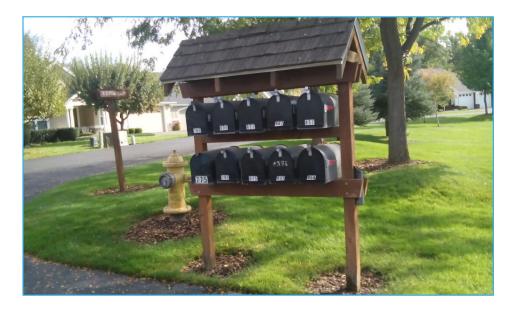
Appears to be deteriorating at a rate typical of their age based on our visual inspection of this component. As routine maintenance, inspect regularly, paint/stain and complete minor repairs as needed from operating budget. Best to plan for total replacement at roughly the time frame indicated due to constant usage, exposure to the elements and wear over time.
