## Villages of Garrison Creek HOA Walla Walla, WA

Account 15551-- Version FINAL September 29, 2016

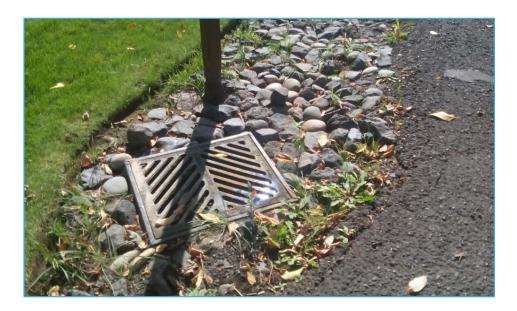
We suggest consulting with a qualified and licensed vendor to set up an annual maintenance paid for from the Operating Account. Currently the Board has stated there has been no maintenance (debris/sediment removal) from the storm water systems in the community. We have given an estimate for this first time service but actual costs may be higher if there is significant amounts of debris/sediment which requires removal.

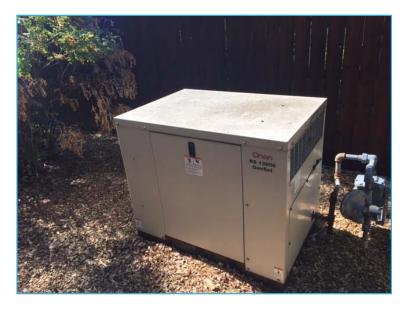
# Sump Pump Backup Generator- Replace- 2027

Gas generator reportedly in working condition and was installed in 2007. We recommend planning for replacement at the timeframe indicated.

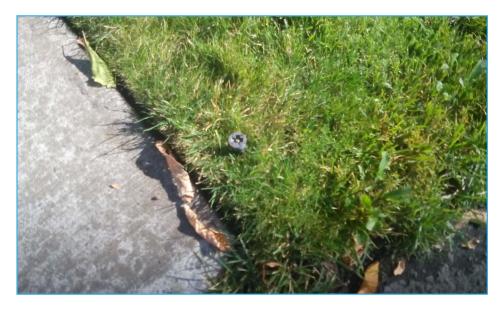
### UG Sprinkler Pipe-Ph. I- Replace 10%-2022

The Board has stated the Association is responsible for the repair & replacement of the front yard underground sprinkler systems.

Underground sprinkler piping, over time, will deteriorate as well as become damaged from root intrusion by trees and shrubs. Due to the age of the community and likelihood of underground sprinkler issues in the near future we recommend for replacement of these pipes at the timeframe indicated which is typical of this type of component. There have reportedly been some areas of repair already required due to root intrusion issues. This cost estimate includes replacement of the underground piping and the landscaping which will be torn up in the process. Since this type of component does not typically fail all at once we recommend funding for a repair contingency of 10% per cycle so that over time the whole system will be replaced.

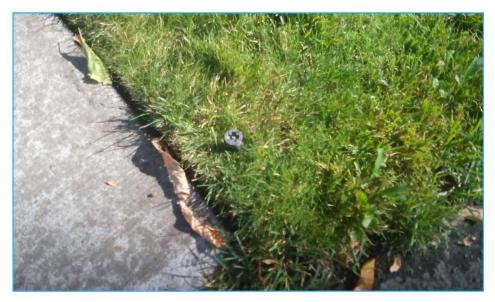
### UG Sprinkler Pipe-Ph. II-Replace 10%-2023

The Board has stated the Association is responsible for the repair & replacement of the front yard underground sprinkler systems.

Underground sprinkler piping, over time, will deteriorate as well as become damaged from root intrusion by trees and shrubs. Due to the age of the community and likelihood of underground sprinkler issues in the near future we recommend for replacement of these pipes at the timeframe indicated which is typical of this type of component. There have reportedly been some areas of repair already required due to root intrusion issues. This cost estimate includes replacement of the underground piping and the landscaping which will be torn up in the process. Since this type of component does not typically fail all at once we recommend funding for a repair contingency of 10% per cycle so that over time the whole system will be replaced.

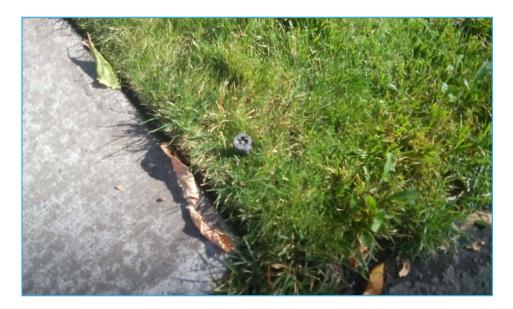
The Board has stated the Association is responsible for the repair & replacement of the front yard underground sprinkler systems.

Underground sprinkler piping, over time, will deteriorate as well as become damaged from root intrusion by trees and shrubs. Due to the age of the community and likelihood of underground sprinkler issues in the near future we recommend for replacement of these pipes at the timeframe indicated which is typical of this type of component. There have reportedly been some areas of repair already required due to root intrusion issues. This cost estimate includes replacement of the underground piping and the landscaping which will be torn up in the process. Since this type of component does not typically fail all at once we recommend funding for a repair contingency of 10% per cycle so that over time the whole system will be replaced.

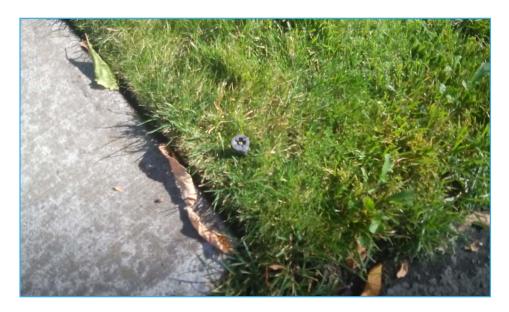
The Board has stated the Association is responsible for the repair & replacement of the front yard underground sprinkler systems.

Underground sprinkler piping, over time, will deteriorate as well as become damaged from root intrusion by trees and shrubs. Due to the age of the community and likelihood of underground sprinkler issues in the near future we recommend for replacement of these pipes at the timeframe indicated which is typical of this type of component. There have reportedly been some areas of repair already required due to root intrusion issues. This cost estimate includes replacement of the underground piping and the landscaping which will be torn up in the process. Since this type of component does not typically fail all at once we recommend funding for a repair contingency of 10% per cycle so that over time the whole system will be replaced.

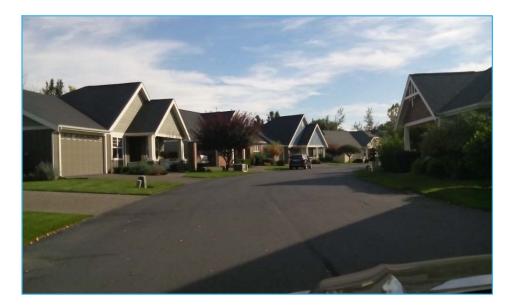
The primary reason to sealcoat is to protect the pavement from the deteriorating effects of sun and water, which causes the asphalt to harden, or oxidize. The pavement turns brittle. The sealcoat provides a waterproof membrane which slows the oxidation process and helps the pavement shed water, preventing the water to infiltrate the base material.

Oil spills eat through the asphalt seal and should be cleaned up between seal coats. Power washing is recommended annually and treated as an operating expense.

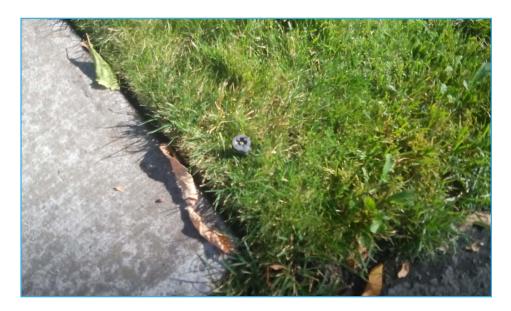
#### UG Sprinkler Pipe- VII- Replace 10%- 2028

The Board has stated the Association is responsible for the repair & replacement of the front yard underground sprinkler systems.

Underground sprinkler piping, over time, will deteriorate as well as become damaged from root intrusion by trees and shrubs. Due to the age of the community and likelihood of underground sprinkler issues in the near future we recommend for replacement of these pipes at the timeframe indicated which is typical of this type of component. There have reportedly been some areas of repair already required due to root intrusion issues. This cost estimate includes replacement of the underground piping and the landscaping which will be torn up in the process. Since this type of component does not typically fail all at once we recommend funding for a repair contingency of 10% per cycle so that over time the whole system will be replaced.

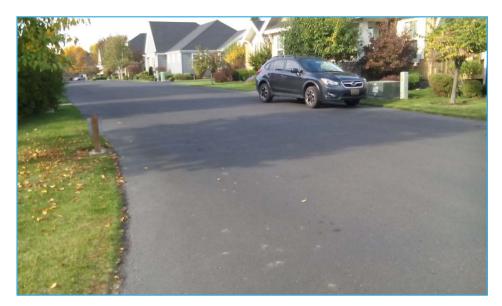
#### Pavement Seal Coat Phase VIII- 2017

The primary reason to sealcoat is to protect the pavement from the deteriorating effects of sun and water, which causes the asphalt to harden, or oxidize. The pavement turns brittle. The sealcoat provides a waterproof membrane which slows the oxidation process and helps the pavement shed water, preventing the water to infiltrate the base material.

Oil spills eat through the asphalt seal and should be cleaned up between seal coats. Power washing is recommended annually and treated as an operating expense.

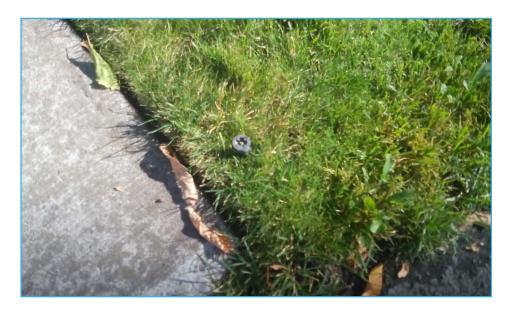
## UG Sprinkler Pipe- VIII- Replace 10%- 2035

The Board has stated the Association is responsible for the repair & replacement of the front yard underground sprinkler systems.

Underground sprinkler piping, over time, will deteriorate as well as become damaged from root intrusion by trees and shrubs. Due to the age of the community and likelihood of underground sprinkler issues in the near future we recommend for replacement of these pipes at the timeframe indicated which is typical of this type of component. There have reportedly been some areas of repair already required due to root intrusion issues. This cost estimate includes replacement of the underground piping and the landscaping which will be torn up in the process. Since this type of component does not typically fail all at once we recommend funding for a repair contingency of 10% per cycle so that over time the whole system will be replaced.

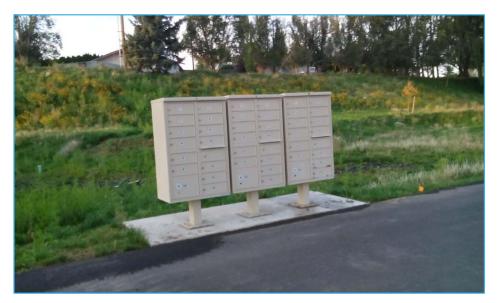
# Mailbox Clusters- Ph. IX- Replace- 2040

Appears to be deteriorating at a rate typical of its age based on our visual inspection of this component. As routine maintenance, inspect regularly, clean by wiping down for appearance, change lock cylinders, lubricate hinges and repair as needed from operating budget. Best to plan for total replacement at roughly the time frame indicated due to constant usage, exposure to the elements and wear over time.

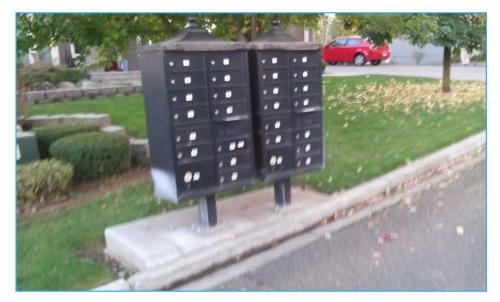
Appears to be deteriorating at a rate typical of its age based on our visual inspection of this component. As routine maintenance, inspect regularly, clean by wiping down for appearance, change lock cylinders, lubricate hinges and repair as needed from operating budget. Best to plan for total replacement at roughly the time frame indicated due to constant usage, exposure to the elements and wear over time.

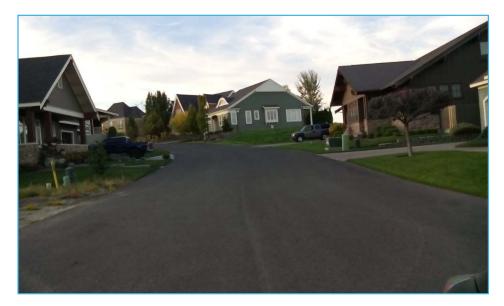
#### Pavement Overlay Phase X-2036

Appears to be deteriorating at a rate typical of its age. As routine maintenance, keep surface clean, ensure that drains are clean and free flowing, repair cracks and clean oils stains promptly. Best to plan for eventual intervals of resurface (overlay).

Most asphalt areas can be expected to last approximately 25-30 years before it will become necessary for an overlay to be applied or other major rehabilitation to be completed. It will be necessary to adjust manhole and valve covers at the time the overlay is applied or other major rehabilitation is completed.

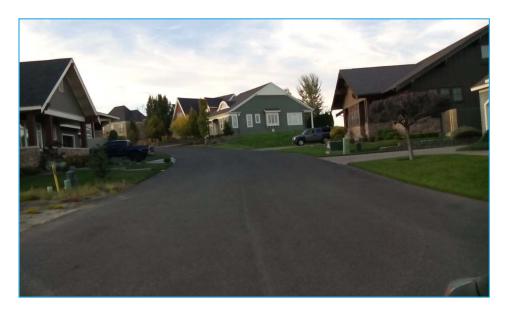
The primary reason to sealcoat is to protect the pavement from the deteriorating effects of sun and water, which causes the asphalt to harden, or oxidize. The pavement turns brittle. The sealcoat provides a waterproof membrane which slows the oxidation process and helps the pavement shed water, preventing the water to infiltrate the base material.

Without regular applications of a seal coat, an asphalt parking lot might need an overlay in 15 years. If the lot is regularly sealed, asphalt areas can last as much as 25-30 years if properly installed.

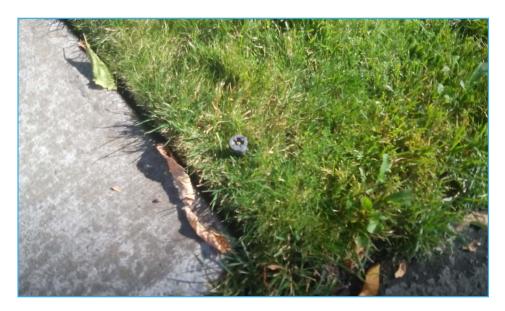
The Board has stated the Association is responsible for the repair & replacement of the front yard underground sprinkler systems.

Underground sprinkler piping, over time, will deteriorate as well as become damaged from root intrusion by trees and shrubs. Due to the age of the community and likelihood of underground sprinkler issues in the near future we recommend for replacement of these pipes at the timeframe indicated which is typical of this type of component. There have reportedly been some areas of repair already required due to root intrusion issues. This cost estimate includes replacement of the underground piping and the landscaping which will be torn up in the process. Since this type of component does not typically fail all at once we recommend funding for a repair contingency of 10% per cycle so that over time the whole system will be replaced.
