Villages of Garrison Creek HOA Walla Walla, WA

Account 15551b-- Version Draft1 October 20, 2017

Villages of Garrison Creek HOA Summary Page

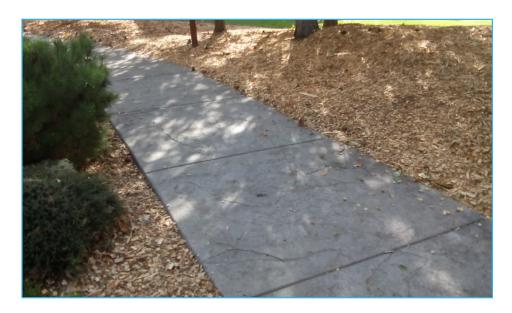
Walking Paths Bark Dust & Chip Rock Refurbish/Replace-2018

This component is for the replacement of the bark and chip rock in the common areas of the community. The cost figures have been provide by the Board and the timeframe of the useful life is based on their estimation to retain the aesthetic appeal of these landscaped areas. While landscaping is often paid for from the Operating Account these large scale projects that do to occur annually can be include in the reserve study.

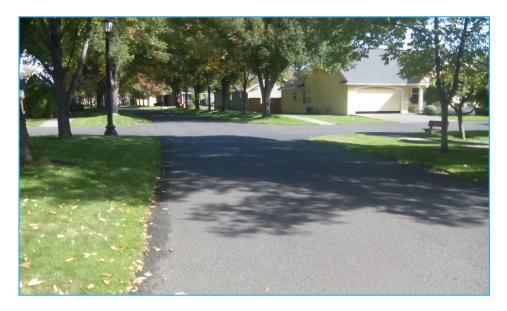
The primary reason to sealcoat is to protect the pavement from the deteriorating effects of sun and water, which causes the asphalt to harden, or oxidize. The pavement turns brittle. The sealcoat provides a waterproof membrane which slows the oxidation process and helps the pavement shed water, preventing the water to infiltrate the base material.

Without regular applications of a seal coat, an asphalt parking lot might need an overlay in 15 years. If the lot is regularly sealed, asphalt areas can last as much as 25-30 years if properly installed.

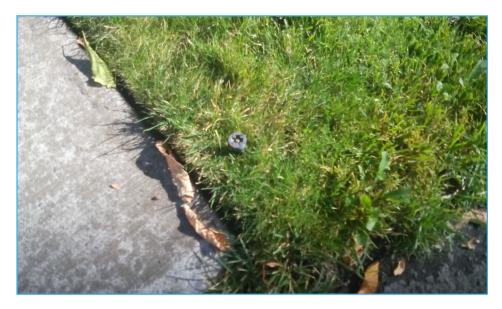
UG Sprinkler Pipe-Ph. I- Replace 10%-2022

The Board has stated the Association is responsible for the repair & replacement of the front yard underground sprinkler systems.

Underground sprinkler piping, over time, will deteriorate as well as become damaged from root intrusion by trees and shrubs. Due to the age of the community and likelihood of underground sprinkler issues in the near future we recommend for replacement of these pipes at the timeframe indicated which is typical of this type of component. There have reportedly been some areas of repair already required due to root intrusion issues. This cost estimate includes replacement of the underground piping and the landscaping which will be torn up in the process. Since this type of component does not typically fail all at once we recommend funding for a repair contingency of 10% per cycle so that over time the whole system will be replaced.

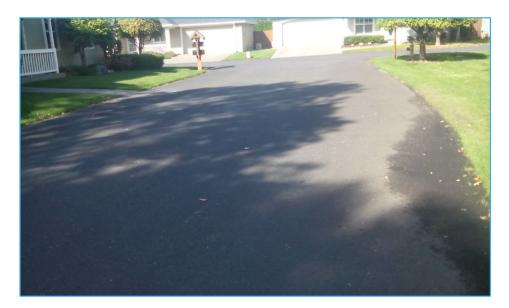
The primary reason to sealcoat is to protect the pavement from the deteriorating effects of sun and water, which causes the asphalt to harden, or oxidize. The pavement turns brittle. The sealcoat provides a waterproof membrane which slows the oxidation process and helps the pavement shed water, preventing the water to infiltrate the base material.

Oil spills eat through the asphalt seal and should be cleaned up between seal coats. Power washing is recommended annually and treated as an operating expense.

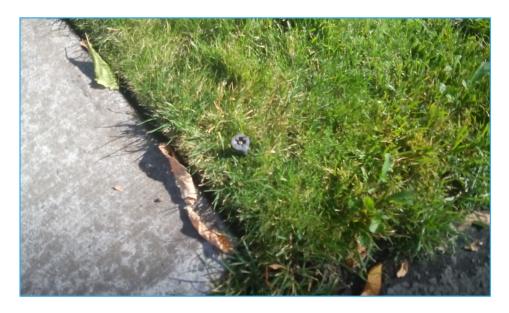
UG Sprinkler Pipe- Ph. II- Replace 10%- 2023

Underground sprinkler piping, over time, will deteriorate as well as become damaged from root intrusion by trees and shrubs. Due to the age of the community and likelihood of underground sprinkler issues in the near future we recommend for replacement of these pipes at the timeframe indicated which is typical of this type of component. There have reportedly been some areas of repair already required due to root intrusion issues. This cost estimate includes replacement of the underground piping and the landscaping which will be torn up in the process. Since this type of component does not typically fail all at once we recommend funding for a repair contingency of 10% per cycle so that over time the whole system will be replaced.

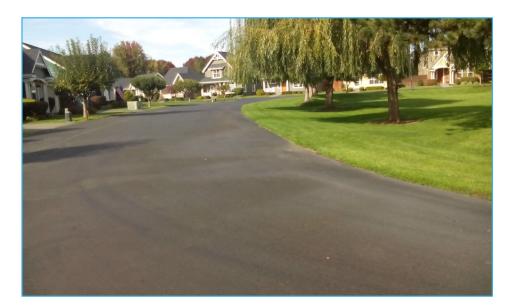
The primary reason to sealcoat is to protect the pavement from the deteriorating effects of sun and water, which causes the asphalt to harden, or oxidize. The pavement turns brittle. The sealcoat provides a waterproof membrane which slows the oxidation process and helps the pavement shed water, preventing the water to infiltrate the base material.

Oil spills eat through the asphalt seal and should be cleaned up between seal coats. Power washing is recommended annually and treated as an operating expense.

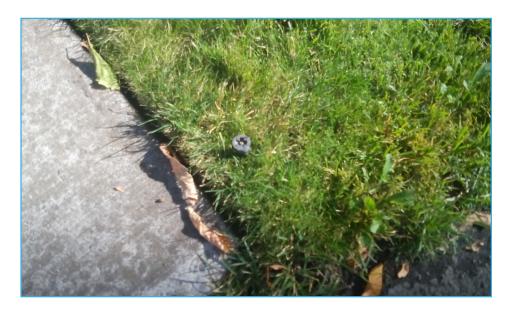
UG Sprinkler Pipe- V- Replace 10%- 2024

Underground sprinkler piping, over time, will deteriorate as well as become damaged from root intrusion by trees and shrubs. Due to the age of the community and likelihood of underground sprinkler issues in the near future we recommend for replacement of these pipes at the timeframe indicated which is typical of this type of component. There have reportedly been some areas of repair already required due to root intrusion issues. This cost estimate includes replacement of the underground piping and the landscaping which will be torn up in the process. Since this type of component does not typically fail all at once we recommend funding for a repair contingency of 10% per cycle so that over time the whole system will be replaced.

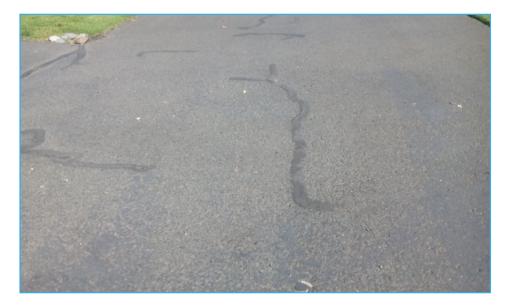
Reportedly areas which were not installed to appropriately. We have reduced the useful life of the asphalt roads in this phase as it is not likely this will last a full 30 years. As routine maintenance, keep surface clean, ensure that drains are clean and free flowing, repair cracks and clean oils stains promptly. Best to plan for eventual intervals of resurface (overlay).

- *Cost estimate based on a 2 inch overlay and includes expectation for minor repairs to areas of the asphalt surfaces at the time of the overlay.
- **Life Adjustment of -7 years due to a a poor install and to coincide with the regular sealcoat cycle for cost efficiency.

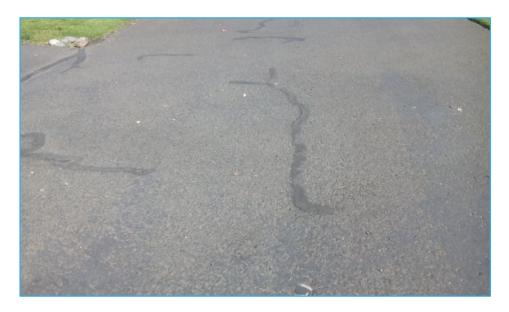
The primary reason to sealcoat is to protect the pavement from the deteriorating effects of sun and water, which causes the asphalt to harden, or oxidize. The pavement turns brittle. The sealcoat provides a waterproof membrane which slows the oxidation process and helps the pavement shed water, preventing the water to infiltrate the base material.

Oil spills eat through the asphalt seal and should be cleaned up between seal coats. Power washing is recommended annually and treated as an operating expense.

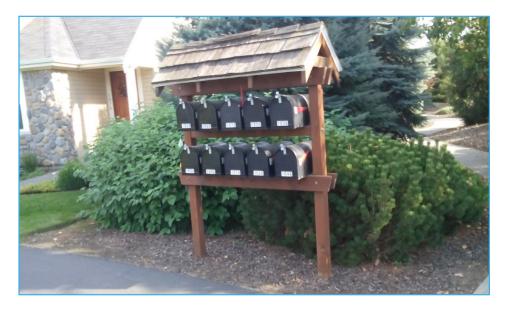
Mailbox Structures - Ph. VII - Replace - 2027

Appears to be deteriorating at a rate typical of their age based on our visual inspection of this component. As routine maintenance, inspect regularly, paint/stain and complete minor repairs as needed from operating budget. Best to plan for total replacement at roughly the time frame indicated due to constant usage, exposure to the elements and wear over time.

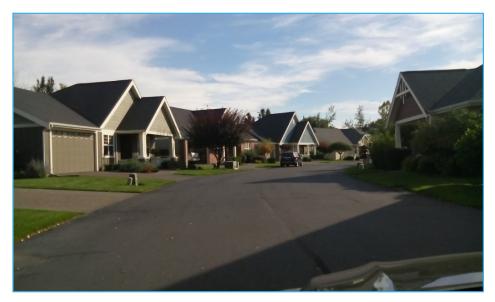
Appears to be deteriorating at a rate typical of its age. As routine maintenance, keep surface clean, ensure that drains are clean and free flowing, repair cracks and clean oils stains promptly. Best to plan for eventual intervals of resurface (overlay).

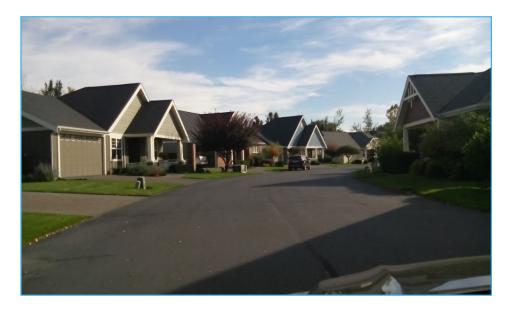
The primary reason to sealcoat is to protect the pavement from the deteriorating effects of sun and water, which causes the asphalt to harden, or oxidize. The pavement turns brittle. The sealcoat provides a waterproof membrane which slows the oxidation process and helps the pavement shed water, preventing the water to infiltrate the base material.

Oil spills eat through the asphalt seal and should be cleaned up between seal coats. Power washing is recommended annually and treated as an operating expense.

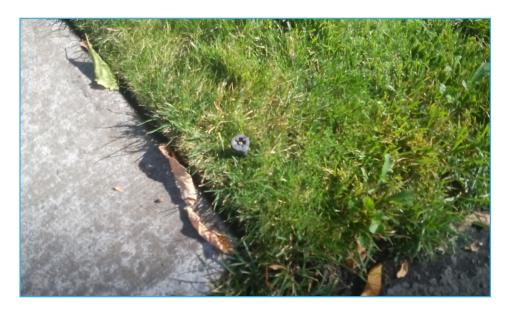
UG Sprinkler Pipe- VII- Replace 10%- 2028

Underground sprinkler piping, over time, will deteriorate as well as become damaged from root intrusion by trees and shrubs. Due to the age of the community and likelihood of underground sprinkler issues in the near future we recommend for replacement of these pipes at the timeframe indicated which is typical of this type of component. There have reportedly been some areas of repair already required due to root intrusion issues. This cost estimate includes replacement of the underground piping and the landscaping which will be torn up in the process. Since this type of component does not typically fail all at once we recommend funding for a repair contingency of 10% per cycle so that over time the whole system will be replaced.

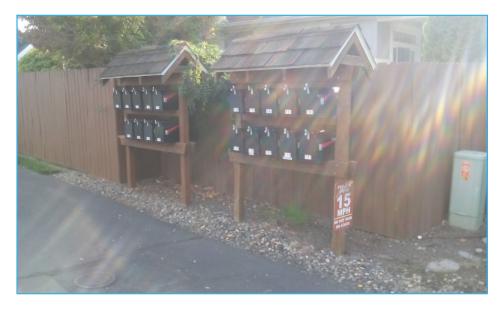
Mailbox Structures - Ph. VIII - Replace - 2034

Appears to be deteriorating at a rate typical of their age based on our visual inspection of this component. As routine maintenance, inspect regularly, paint/stain and complete minor repairs as needed from operating budget. Best to plan for total replacement at roughly the time frame indicated due to constant usage, exposure to the elements and wear over time.

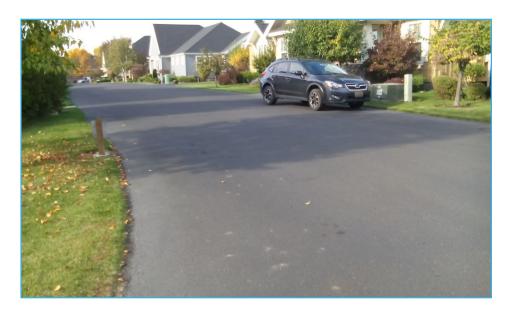
Appears to be deteriorating at a rate typical of its age. As routine maintenance, keep surface clean, ensure that drains are clean and free flowing, repair cracks and clean oils stains promptly. Best to plan for eventual intervals of resurface (overlay).

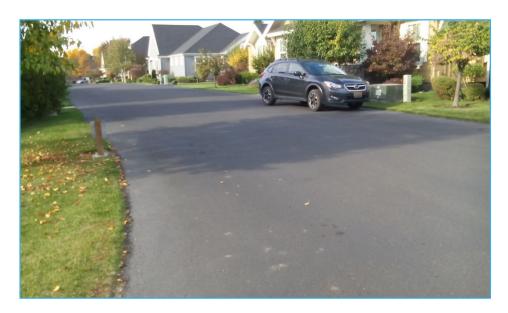
The primary reason to sealcoat is to protect the pavement from the deteriorating effects of sun and water, which causes the asphalt to harden, or oxidize. The pavement turns brittle. The sealcoat provides a waterproof membrane which slows the oxidation process and helps the pavement shed water, preventing the water to infiltrate the base material.

Oil spills eat through the asphalt seal and should be cleaned up between seal coats. Power washing is recommended annually and treated as an operating expense.

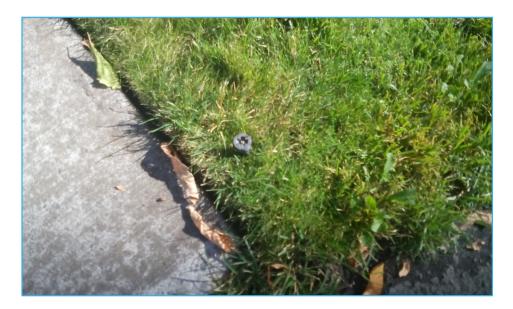
UG Sprinkler Pipe- VIII- Replace 10%- 2035

Underground sprinkler piping, over time, will deteriorate as well as become damaged from root intrusion by trees and shrubs. Due to the age of the community and likelihood of underground sprinkler issues in the near future we recommend for replacement of these pipes at the timeframe indicated which is typical of this type of component. There have reportedly been some areas of repair already required due to root intrusion issues. This cost estimate includes replacement of the underground piping and the landscaping which will be torn up in the process. Since this type of component does not typically fail all at once we recommend funding for a repair contingency of 10% per cycle so that over time the whole system will be replaced.

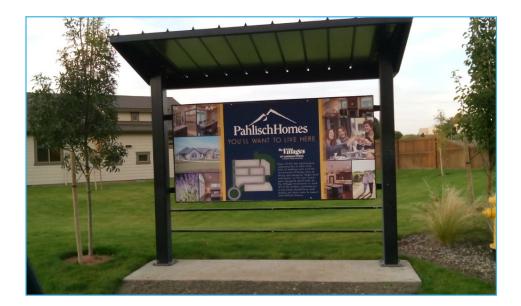
Bus Stop-Ph. IX-Replace-2055

The metal bus top cover appear to be in good overall condition. If properly maintained with regular intervals of cleaning and painting (paid for from the operating budget) this component is a long life item which will not have a replacement cycle within the timeframe of this reserve study. If at a future date this structure appears to be deteriorating more rapidly then expected we recommend incorporating into future reserve studies for replacement.

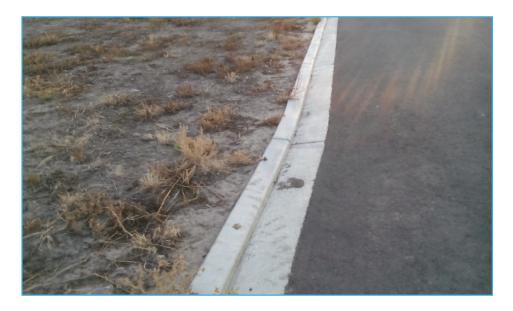
Concete- Curb Ph. IX- Repair- 2055

Good condition with no areas of cracking or damage noted. No instability observed at this time. Inspect regularly, pressure wash for appearance and repair as needed from operating budget. No expectation for large scale replacement at this time, if patterns of deterioration emerge, incorporate funding into future reserve study updates as conditions merit.

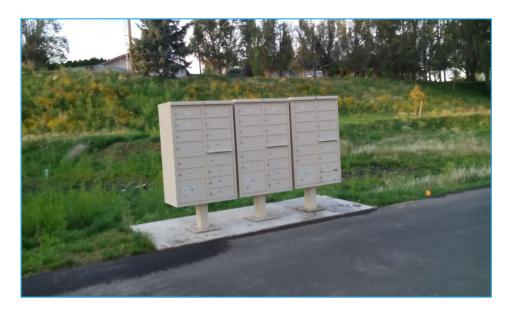
Mailbox Clusters-Ph. IX-Replace-2040

Appears to be deteriorating at a rate typical of its age based on our visual inspection of this component. As routine maintenance, inspect regularly, clean by wiping down for appearance, change lock cylinders, lubricate hinges and repair as needed from operating budget. Best to plan for total replacement at roughly the time frame indicated due to constant usage, exposure to the elements and wear over time.

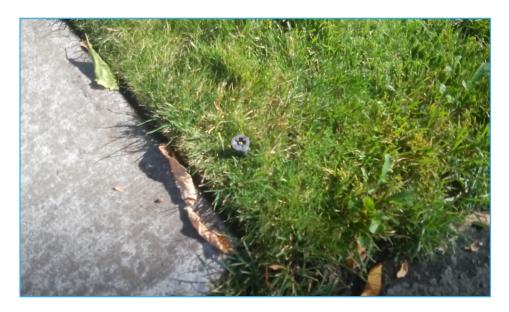
Underground sprinkler piping, over time, will deteriorate as well as become damaged from root intrusion by trees and shrubs. Due to the age of the community and likelihood of underground sprinkler issues in the near future we recommend for replacement of these pipes at the timeframe indicated which is typical of this type of component. There have reportedly been some areas of repair already required due to root intrusion issues. This cost estimate includes replacement of the underground piping and the landscaping which will be torn up in the process. Since this type of component does not typically fail all at once we recommend funding for a repair contingency of 10% per cycle so that over time the whole system will be replaced.

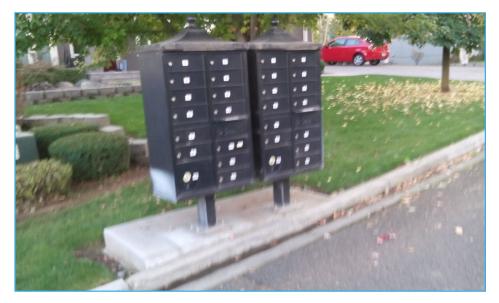
Appears to be deteriorating at a rate typical of its age based on our visual inspection of this component. As routine maintenance, inspect regularly, clean by wiping down for appearance, change lock cylinders, lubricate hinges and repair as needed from operating budget. Best to plan for total replacement at roughly the time frame indicated due to constant usage, exposure to the elements and wear over time.

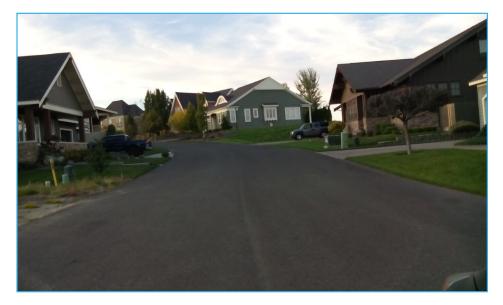
Pavement Overlay Phase X-2036

Appears to be deteriorating at a rate typical of its age. As routine maintenance, keep surface clean, ensure that drains are clean and free flowing, repair cracks and clean oils stains promptly. Best to plan for eventual intervals of resurface (overlay).

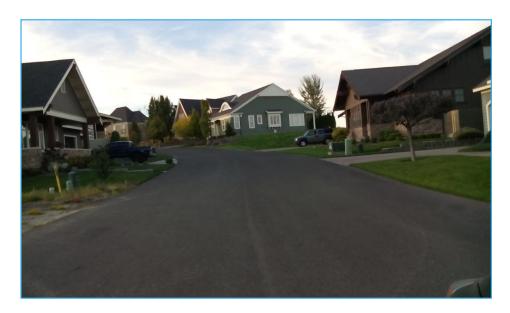
The primary reason to sealcoat is to protect the pavement from the deteriorating effects of sun and water, which causes the asphalt to harden, or oxidize. The pavement turns brittle. The sealcoat provides a waterproof membrane which slows the oxidation process and helps the pavement shed water, preventing the water to infiltrate the base material.

Without regular applications of a seal coat, an asphalt parking lot might need an overlay in 15 years. If the lot is regularly sealed, asphalt areas can last as much as 25-30 years if properly installed.

Oil spills eat through the asphalt seal and should be cleaned up between seal coats. Power washing is recommended annually and treated as an operating expense.
