Villages of Garrison Creek HOA

College Place, WA

Level II Update Reserve Study (With Site-Visit)

Fiscal Year: 2020 Report#: 15954 Version: Final

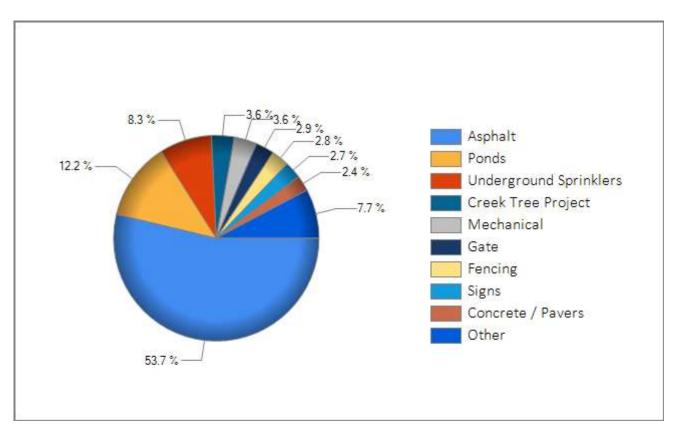
The above chart illustrates the current cost breakdown percentage of the Component Categories in this reserve study (highest percentage components listed at top). Special attention should be given to those component categories which take up a bulk of the % of the current cost as these may require significant planning to adequately budget for their replacement. These large expenses may be well into the future during "Peak Year" cycles. Refer to the Cash Flow Projections and the Annual Expenditure Report for the projected timeline of expected expenditures.

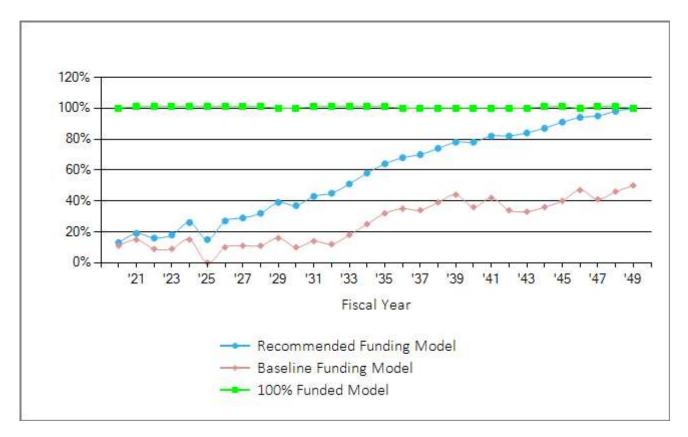
The above chart compares the funding models by the percentage funded levels over the 30-year timeframe of this reserve study, as calculated at the end of each fiscal year.

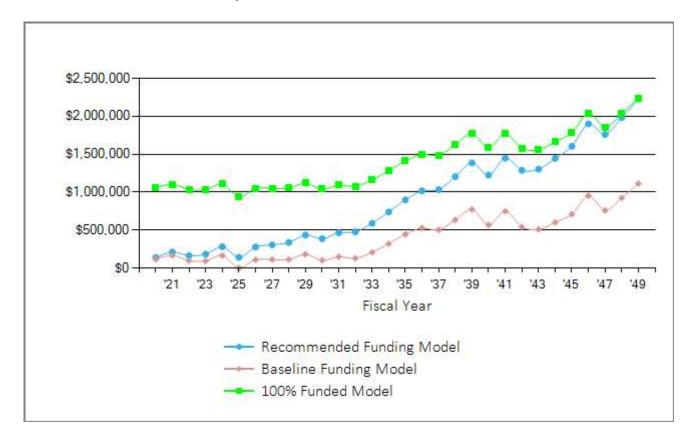
Villages of Garrison Creek HOA Projected Reserve Account Balance Chart

The chart above compares the annual year-end balance of the reserve account for the respective funding models over the 30 years covered in this reserve study. Projected reserve account balances will see large fluctuations from year to year due to projects occurring in any given year.

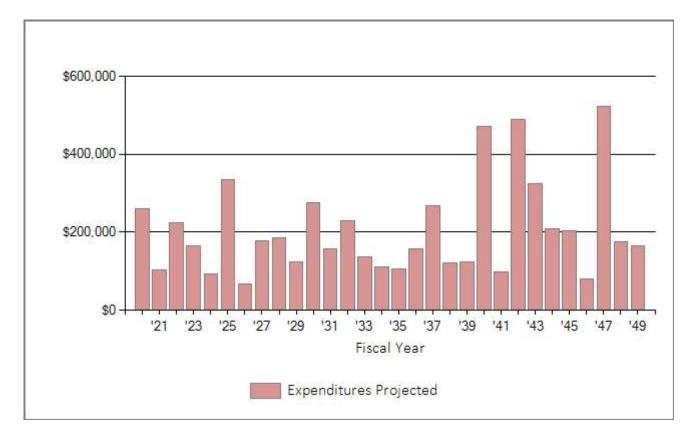
The above chart provides a visual of the reserve account projected expenditures over the 30 years covered in this study. We suggest making a note of large expenditure years (peak years) when there will be significant projected expenditures related to one or more component projects that will require repair/replacement. These large but infrequent component expenses during "peak" years are typically the most difficult to budget for as they are often overlooked or ignored due to the perception that the expenses are far in the future and there will be time to budget for them later.

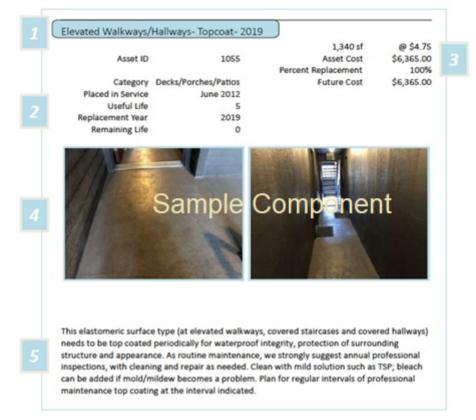
- 1. Component Name and next Replacement Year as well as a unique Asset ID to cross reference with other sections within this reserve study.
- 2. This area has the category of the component, estimated placed in-service date (when last installed), the estimated useful life of the component (estimate of how long the component will last), the next replacement year in this reserve study and the remaining useful life (how many years before replacement is estimated to occur).

- 3. The area has the total measurement/unit count of the component, the cost per unit, the total asset cost (unit count X unit cost), the percent replacement (amount funded to be replaced in a cycle), and the future cost (estimated cost at the next replacement date).
